**PHASE IA/IB CULTURAL RESOURCES SURVEY
OLD ROOSEVELT FIELD CONTAMINATED GROUNDWATER
AREA SUPERFUND SITE, OPTION 2
VILLAGE OF GARDEN CITY, NASSAU COUNTY
NEW YORK**

FEBRUARY 2013

RICHARD GRUBB & ASSOCIATES, INC.
Cultural Resource Consultants

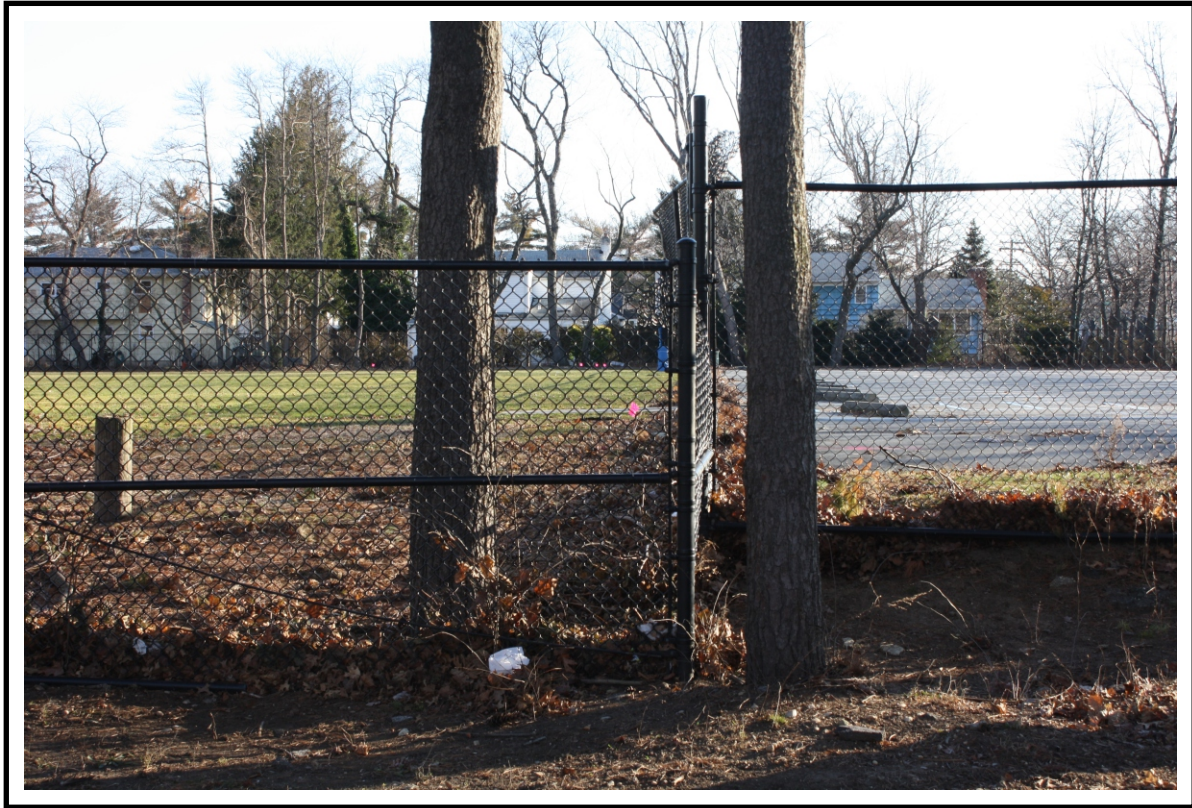
Photograph 1:

Overview of Section C of the APE showing the ball field elevation in relationship to the school yard to the west.

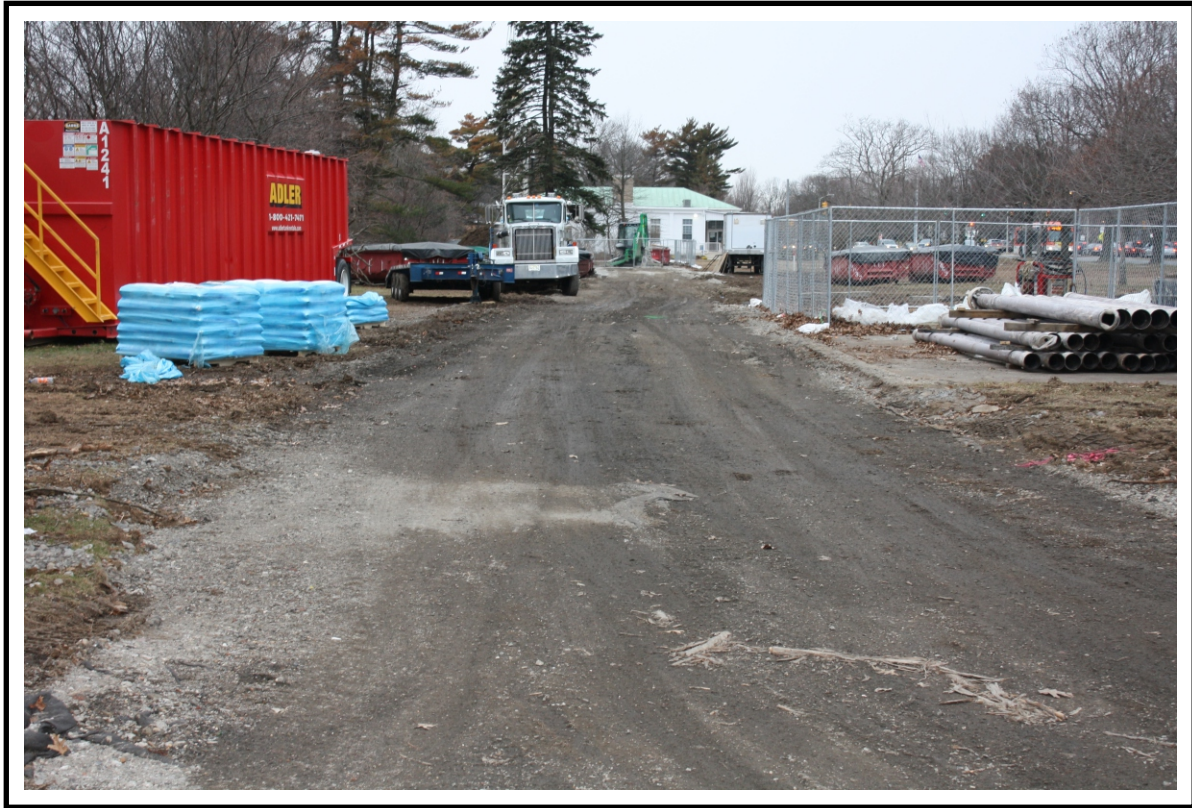
Photograph 3:

Disturbances noted in the western portion of Section A of the APE. Note: the green roofed building in the background is a modern bank building that is in the approximate location of the A.T. Stewart structure shown on the 1873 Beers atlas and the Curtiss Engineering Corp. on the 1927 Belcher-Hyde map.

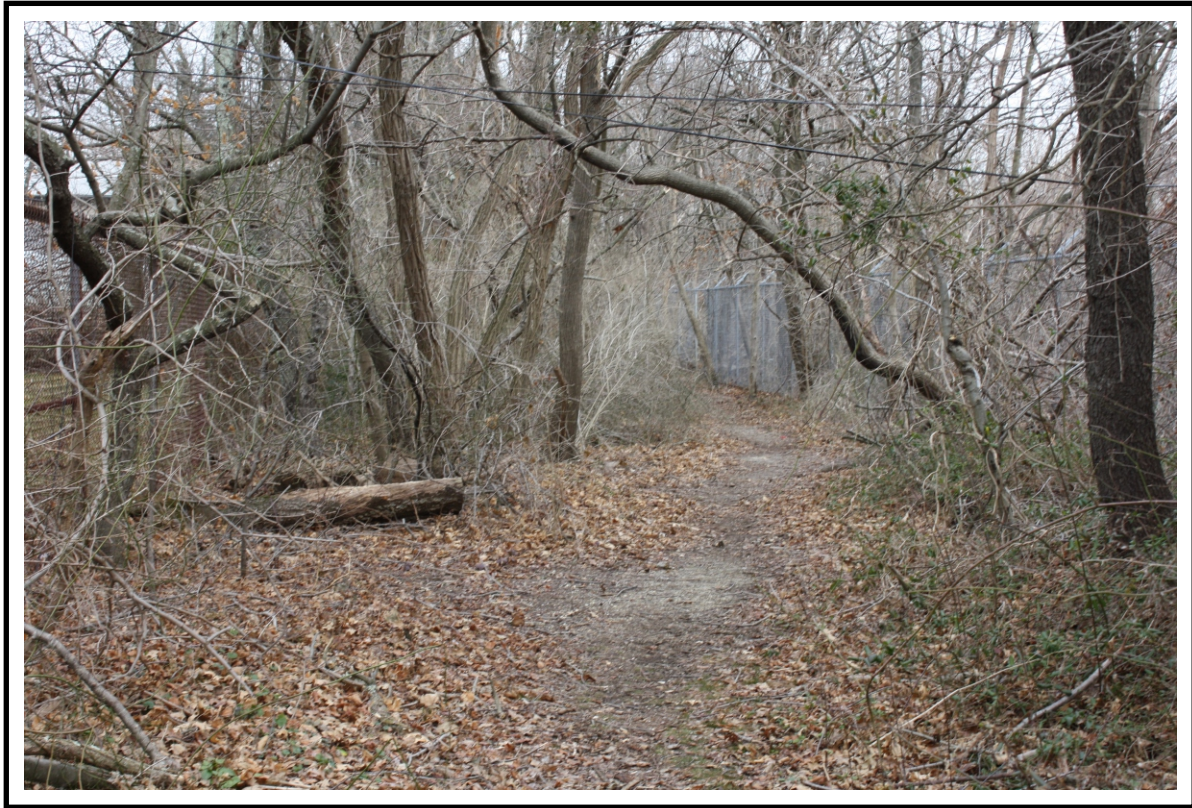
Photograph 4:

Portions of the Long Island Motor Parkway within the APE (Section E).

The previous Phase IA cultural resources survey completed for this project (JMA 2005) noted the presence of a remnant section of the Long Island Motor Parkway. This surviving segment of the Long Island Motor Parkway consists of the eastern bridge embankment of the Parkway's Clinton Road Bridge and a 0.3 kilometer (0.2 mile) segment of the Parkway roadbed. Features related to the Long Island Motor Parkway within the APE include the asphalt road bed, several concrete guard rail posts that formerly would have contained cable guard rails, and concrete curbs that did not appear to be intact (Photographs 4-8). Proposed impacts to the surviving segment of the Long Island Motor Parkway as part of the proposed remediation project consist of the placement of a trench to carry the six-inch pipeline within the roadbed. Based on a February 11, 2013 email from Lorraine Weiss of the OPRHP, the portion of the Long Island Motor Parkway within the APE is considered to lack "integrity of setting, design, materials, craftsmanship, and feeling" (see Appendix C) and is considered ineligible for listing on the State and National Registers of Historic Places.

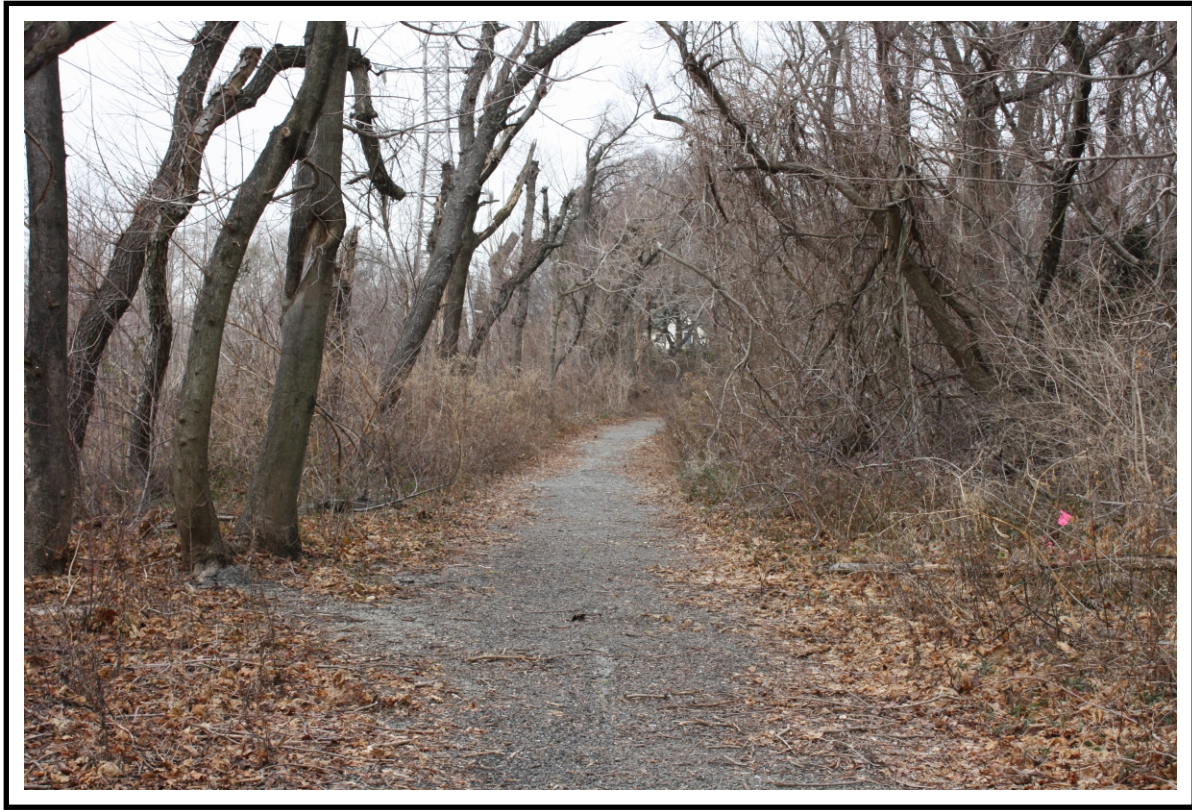
Photograph 5:

Portions of the Long Island Motor Parkway within the APE (Section E).

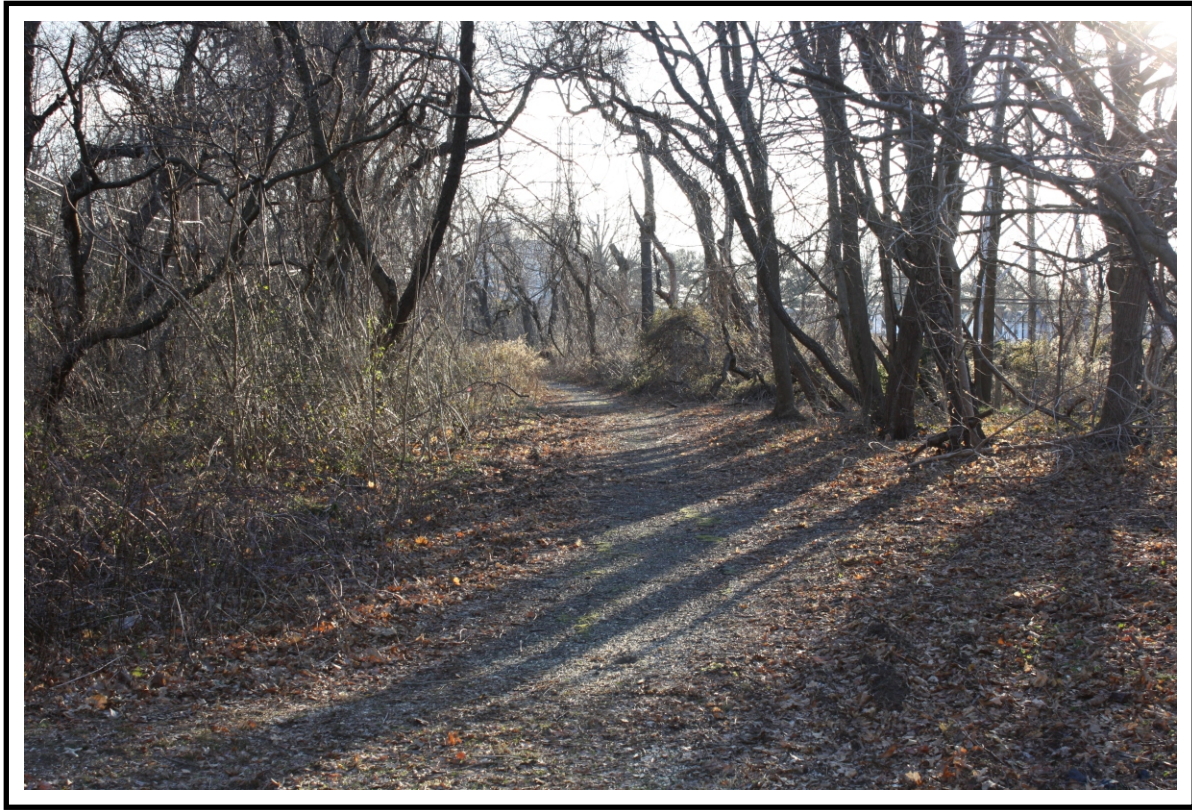
Photograph 6:

Portions of the Long Island Motor Parkway within the APE (Section E).

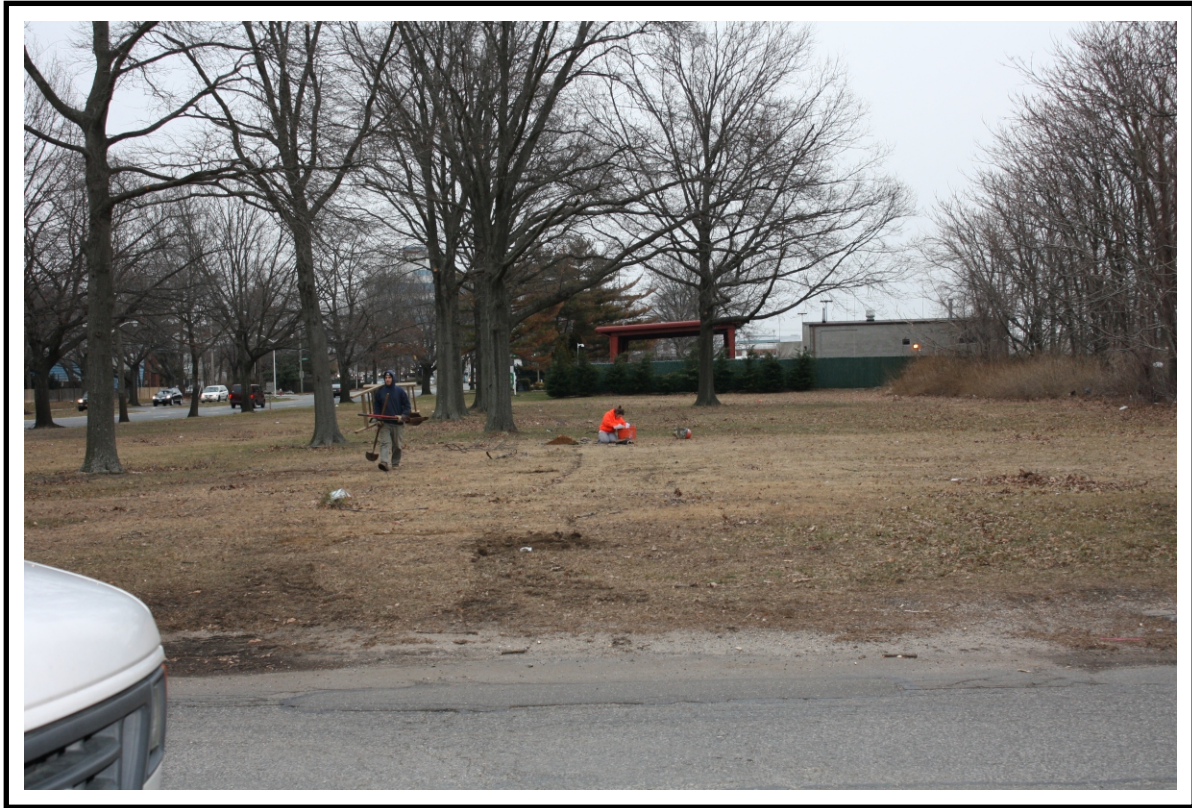
Photograph 9:

Park-like setting in the eastern end of Section A of the APE.

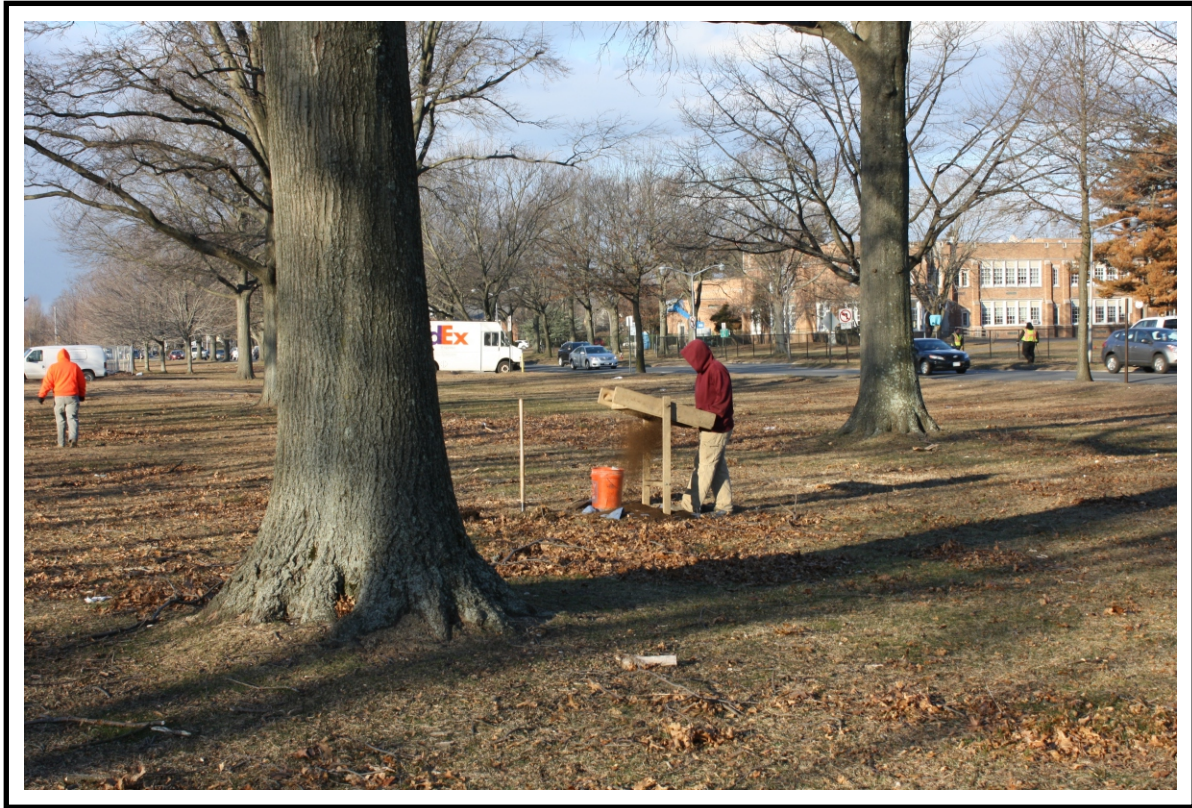
Photograph 10:

Work in progress in the eastern end of Section A of the APE. The National Register-eligible Stewart Elementary School is in the background across Stewart Avenue.

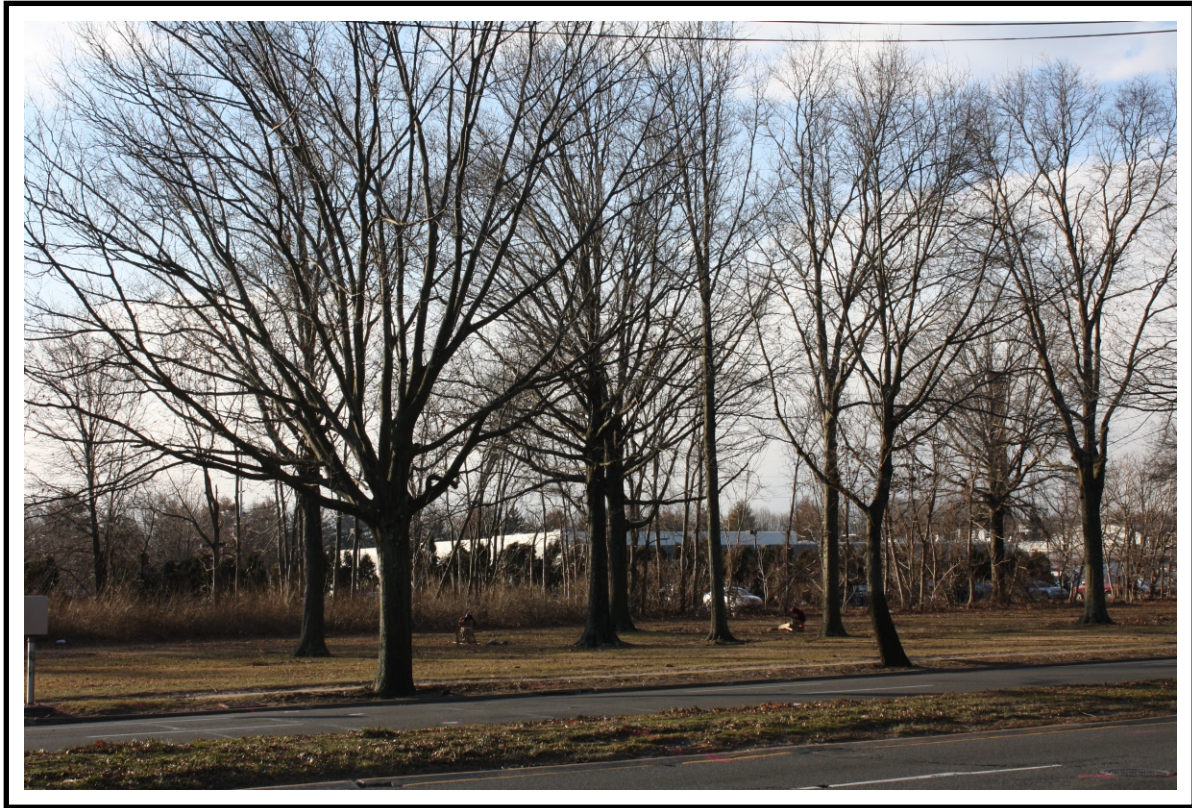
Photograph 11:

Work in progress in the eastern end of Section A of the APE.

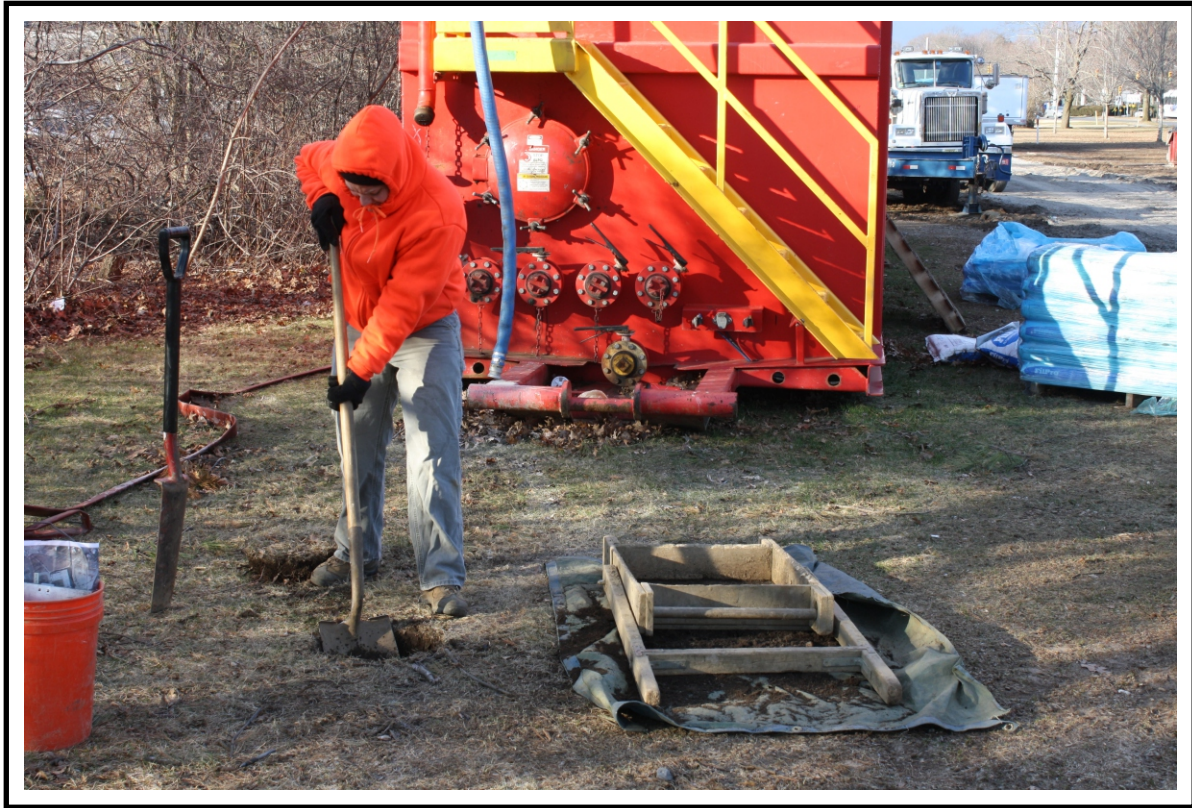
Photograph 12:

Work in progress on STP 28 in the western end of Section A of the APE. These STPs were placed in undisturbed grassy areas adjacent to the APE.

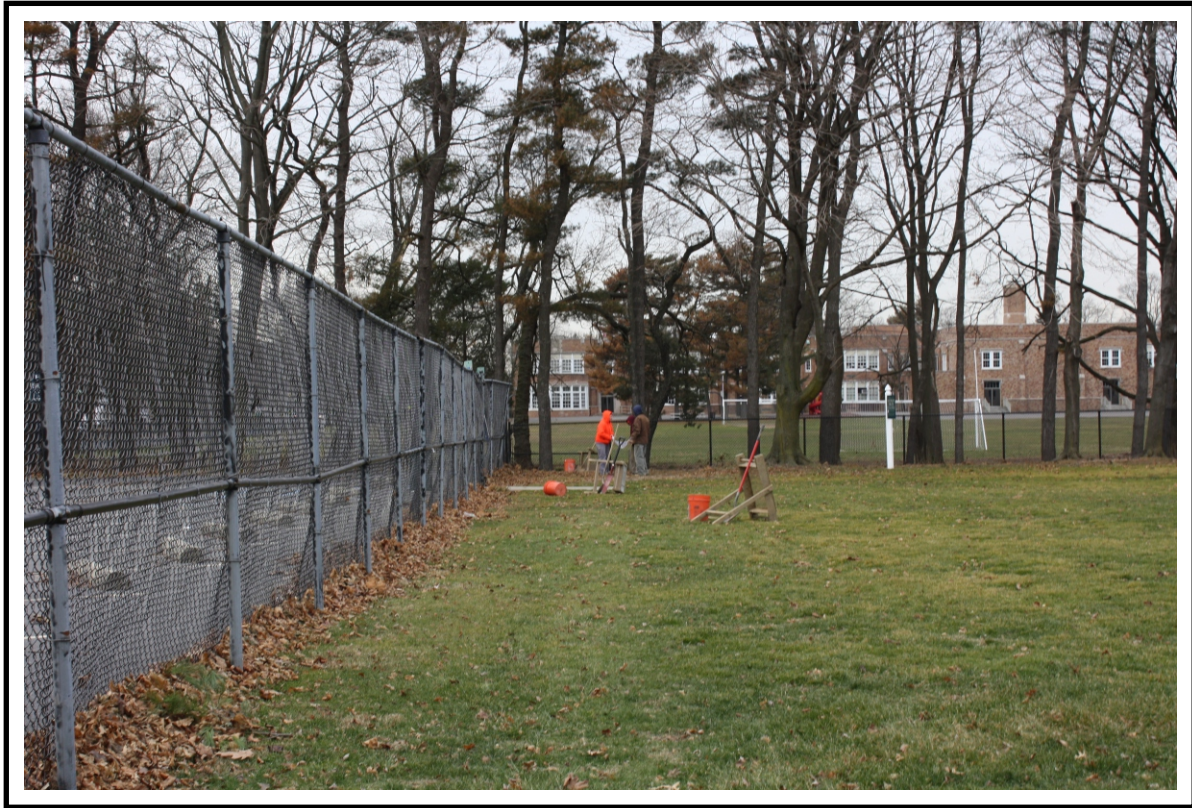
Photograph 14:

Area of STPs 1-5 alongside the fence at the south end of the ball field
(Section C).

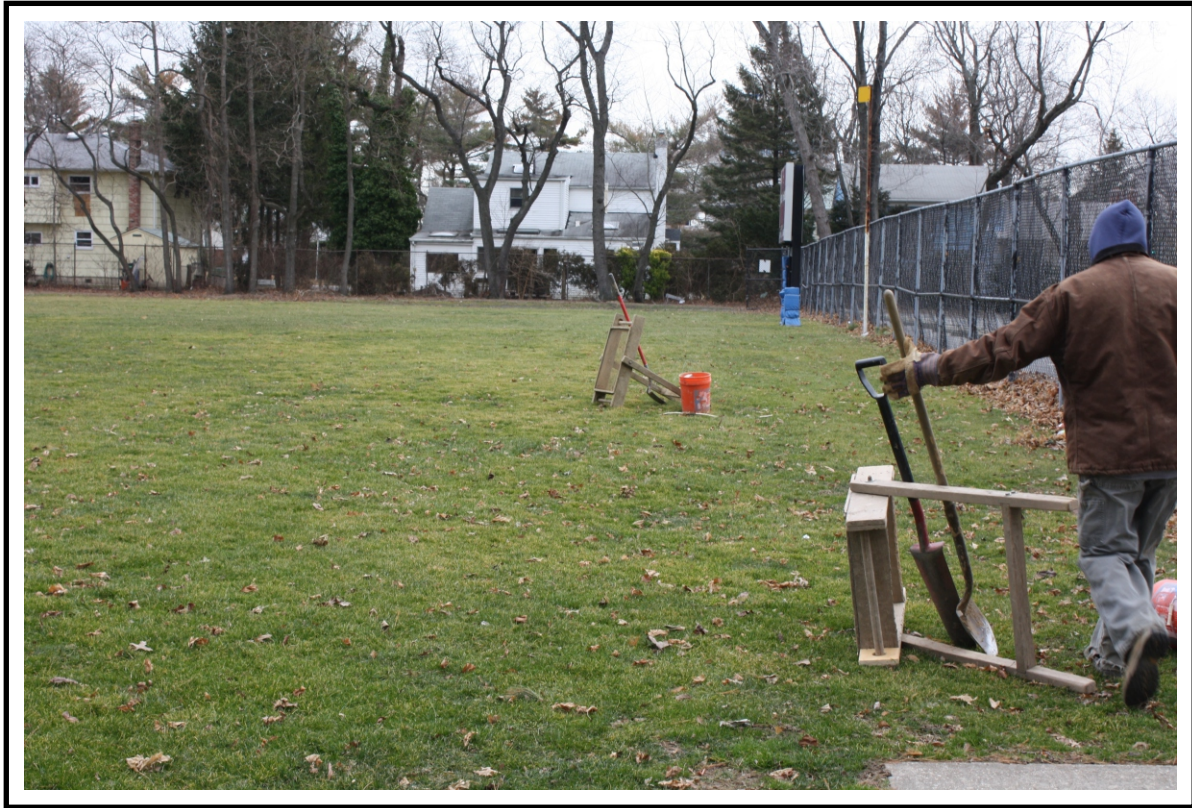
Photograph 15:

Area of STPs 1-5 alongside the fence at the southern end of the ball field (Section C).

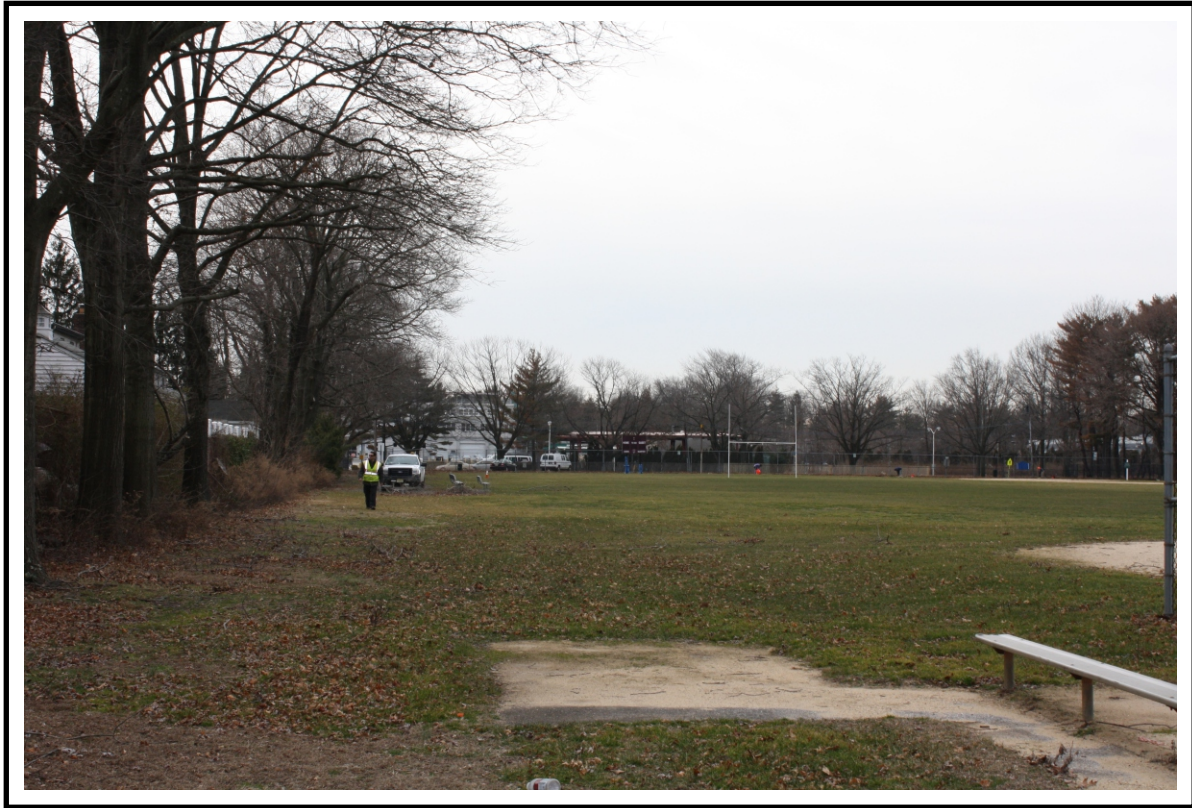
Photograph 16:

Area of STPs 6-17 at the northern end of the ball field (Section D).
